## Errata of

### *Embedded SoPC Design with Nios II Processor and Verilog Examples*

(Last Updated 08/01/2012)

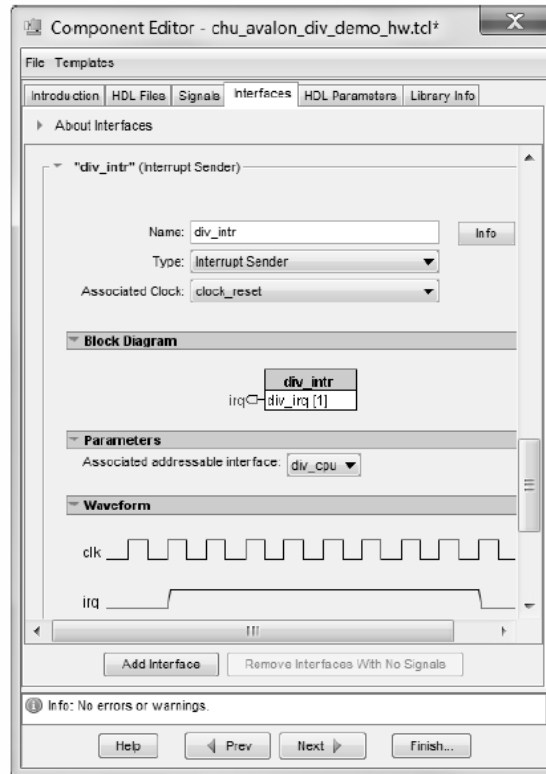
- p.377, Figure 15.19: wrong image was embedded: the correct one should be
